BUSHFIRE HAZARD REPORT

Proposed alterations & additions to an existing dwelling
231 Cripps Road
Woodbridge, 7162

Dated 29th January 2026
Report by David Lyne BFP-144
Version 3.0 – 17.03.2026 – updated BHMP

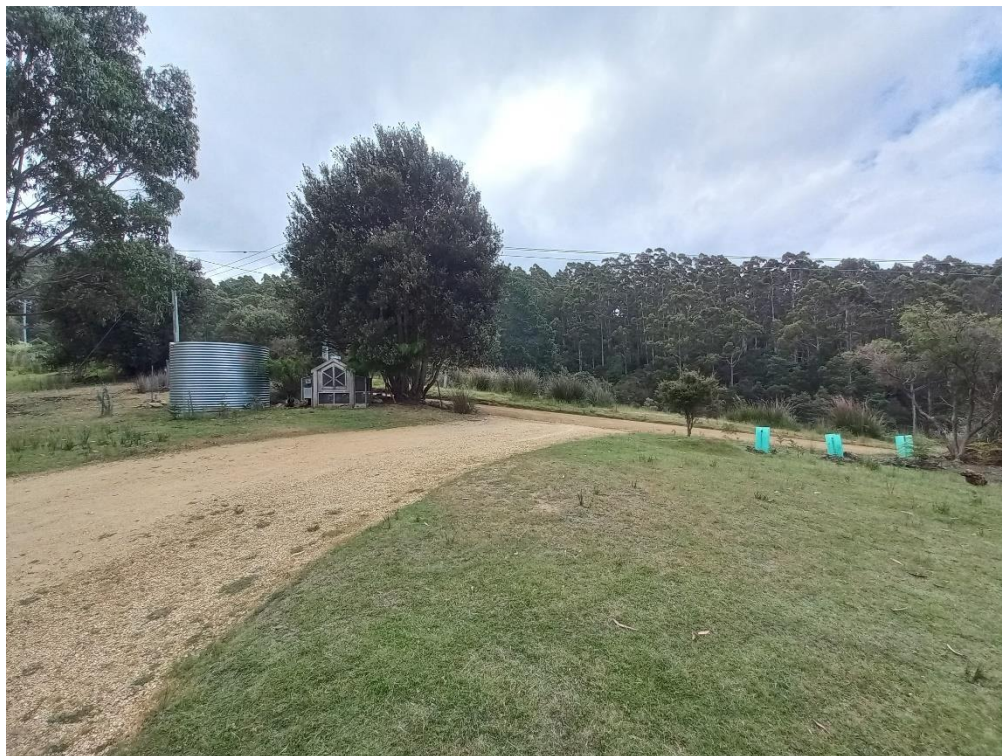
Looking north

231 Cripps Road Woodbridge is an existing land parcel, located in the municipality of the Kingborough Council. The property contains mostly forest vegetation to the south of the existing dwelling and outbuildings, with grassland and forest to all other directions. Neighbouring properties currently contain mostly forest to all directions, with some grassland present to the north.
